Manhole Inspection Summary

Manhole # S35UU_005MH

Insp Date: 1/11/07 12:15 PM

Location Address: **346 BARCLAY ST**

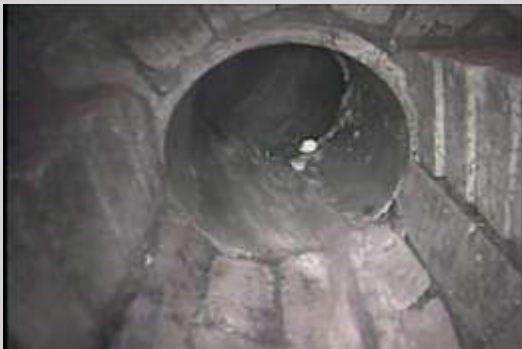
8 in. Circular Gravity Sewer Pipe In @ 3 O'Clock

Pipe Material: **Clay** ☐ Pipe Lined

Invert Depth: **10.21** (ft.) Flow Characteristics: **Fast**

Deposits: ☒ None ☐ Mud ☐ Sludge ☐ Debris ☐ Grease

Infiltration: **None** Pipe Seal Cond: **Sound**

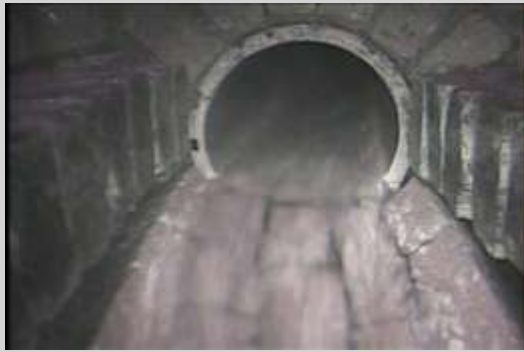
10 in. Circular Gravity Sewer

Pipe Material: **Clay** ☐ Pipe Lined

Infiltration: **None** Pipe Seal Cond: **Sound**
